# DIAGNOSIS OF PATHOLOGIES IN BRIDGES OF THE ROAD SYSTEM IN BRAZIL

*Cleovir José Milani<sup>1</sup> and Moacir Kripka<sup>2</sup>*

The aim of this paper is to present a study of the structural conditions and pathological manifestations of the bridges in the city of Pato Branco, seeking to ensure the correct functioning of the transportation infrastructure in the preservation of public property and safety for the users. With this purpose, it was originally performed the geographical mapping of the bridges in the city of Pato Branco, which were, in sequence, identified and characterized by type of structure, size, age and material.

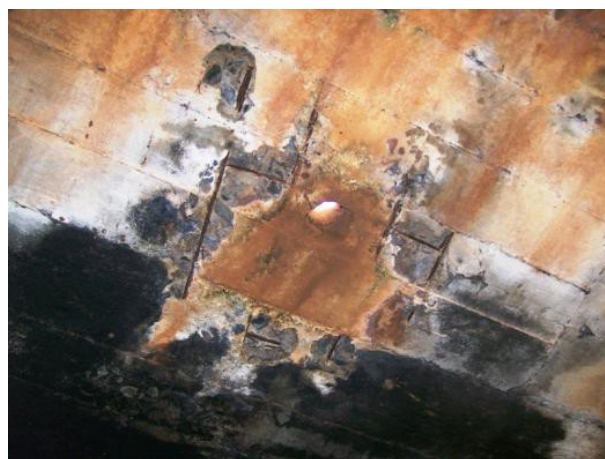
The bridge of Figure 8 shows, near the drain pipes, stains and peeling from the concrete and apparent reinforcement in advanced stages of corrosion. It is an established fact that one of the most common symptoms and impairment are the stains on the concrete and corrosion of reinforcement.

**Figure 8.** Peeling of concrete and corrosion of reinforcement

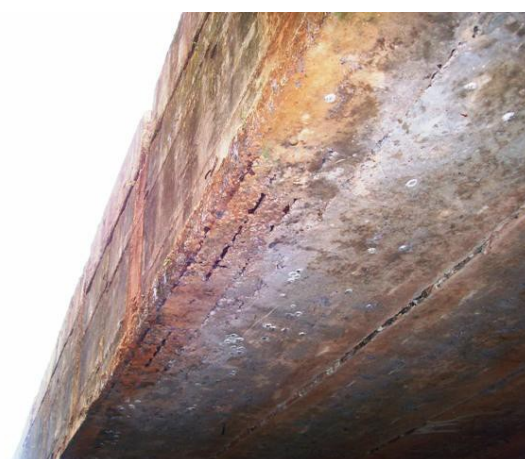
**Figure 9.** Reinforcement corrosion of the side beam of the bridge

The bridge of Figure 9 shows accelerated corrosion caused by the lack of drip tray on the side and improper coating on the reinforcement. Incorrect use of drip pans and nests of concrete in concrete structures is a failure that may, individually or together, create the necessary conditions to reduce the life cycle of the structures.

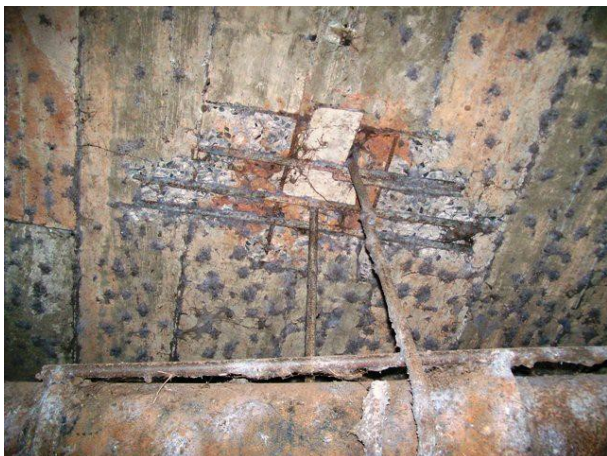
**Figure 10.** Detail of fixed pipes in the slab of the bridge

One can check on the bridge of Figure 10 the detail of fixed pipes in the slab of the bridge. There is lack of planning for attaching external elements such as pipes, causing a starting point of corrosion process of the reinforcement. The rain water galleries were performed directly on the slab of the bridge. In Fig. 11 it is noticed that the corrosive process is intense because of constant moisture.

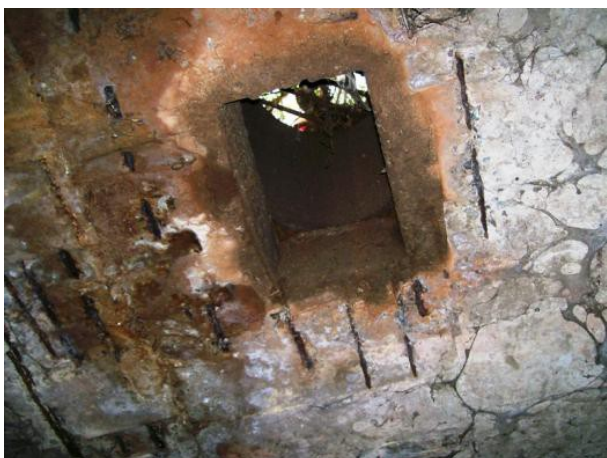
**Figure 11.** Bottom view of the slab in the access of rainwater drainage

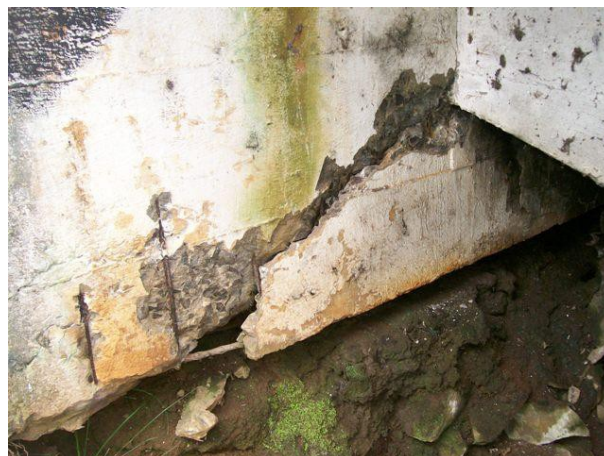
On the bridge of Fig. 12 there is a disruption of the structural element in the balance of access. Among the pathological problems found in the bridge we noticed the excessive apparent vibration felt during the inspection of the bridge

**Figure 12.** Disruption of the access balance of the bridge structure

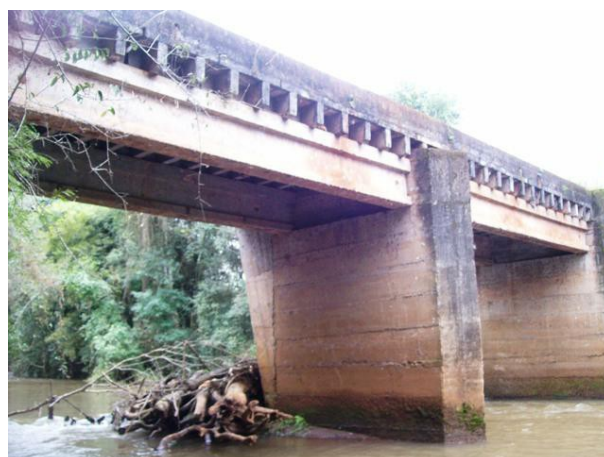
The impact on the structures of the bridges (Fig. 13) in the city of Pato Branco occurs, almost entirely, due to tree trunks that are dragged by water streams and end up colliding with structural elements of bridges, causing damage to the structure.

**Figure 13.** Tree trunks impacting on the pillar

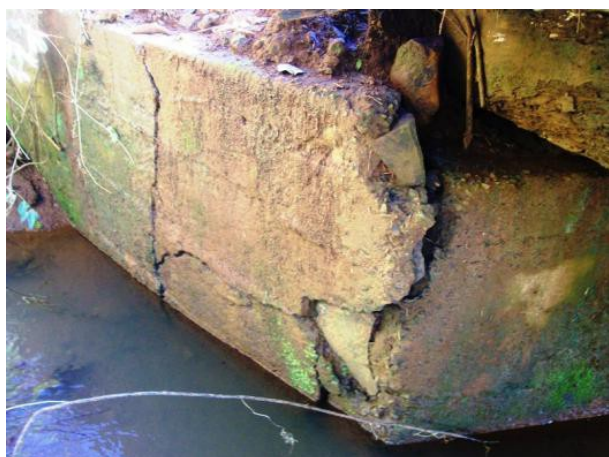
It can be seen on the bridge of Fig. 14 that it is the containment of the landfill and support beams of a wooden bridge, where erosion has occurred in the foundations causing the disruption of the concrete. The lack of

reinforcement is visible on this support structure.

**Figure 14.** Disruption of the support and containment concrete of the bridge

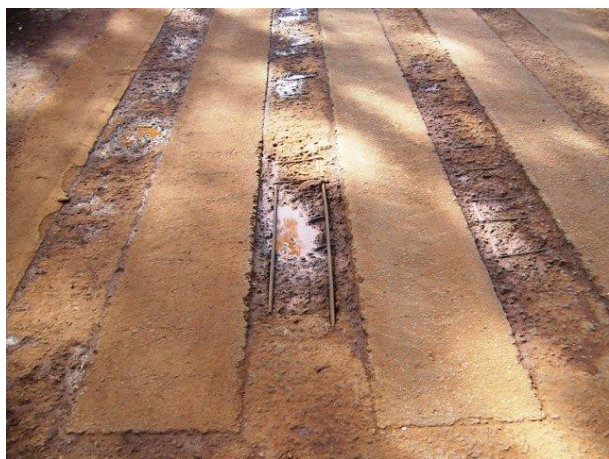
On the bridge of Fig. 15 it can be seen, apparently, the phenomenon of abrasion caused by the friction of vehicular traffic, causing deterioration on the concrete pavement of the board and exposing the reinforcement.

**Figure 15.** Deterioration of the concrete pavement with reinforcement exposure

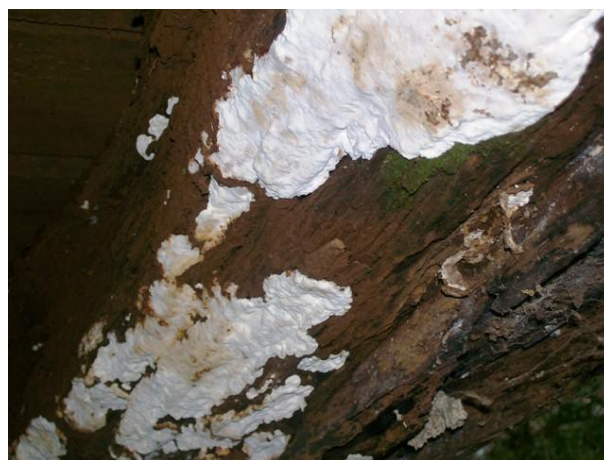
On the bridge of Fig. 16 the beam is attacked by microorganisms, bacteria and fungi that cause the wood to rot. In wooden structures of bridges fungi meet favorable conditions for their development because of

favorable factors such as humidity, temperature, oxygen, little sunlight.

**Figure 16.** Wood attack by bacteria and fungi (Bridge P119)

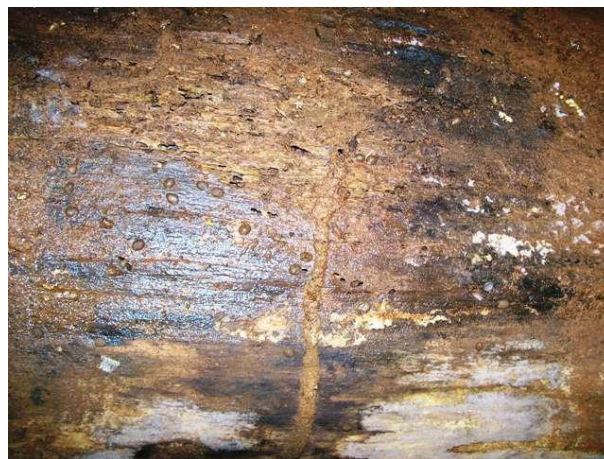
It can be seen on the bridge of Fig. 17 the attack of insects in the logs (support beams of the bridges). The wood suffers attack from several species of insects such as termites and larvae, which use the wood as a shelter and source of feeding

The insects produce galleries which reduce dangerously the resistant sections of the parts in service, facilitating the entry of moisture, necessary for the development of fungi.

**Figure 17.** Insect attack in logs (beams) of the bridge support

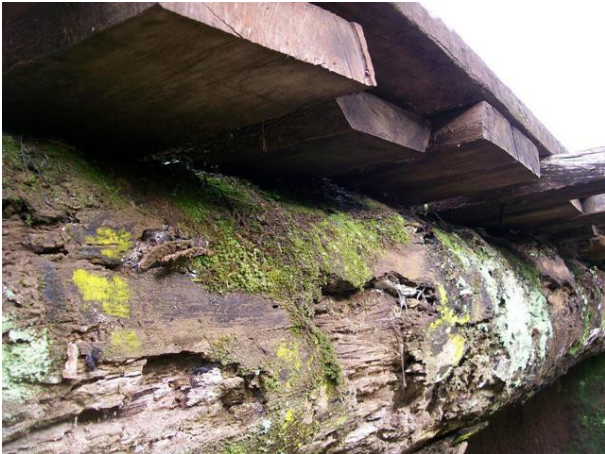
On the bridge of Fig. 18 one can notice the rotting of the wood caused by the attack of biotic agents.

**Figure 18.** Bridge beam rotting

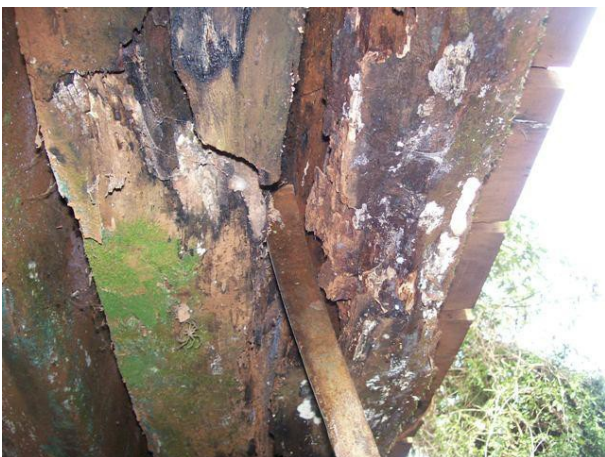
On the bridge of Fig. 19 there is an advanced stage of deterioration with rupture of the beam, indicating an imminent collapse.

**Figure 19.** Wooden beam at an advanced stage of decomposition

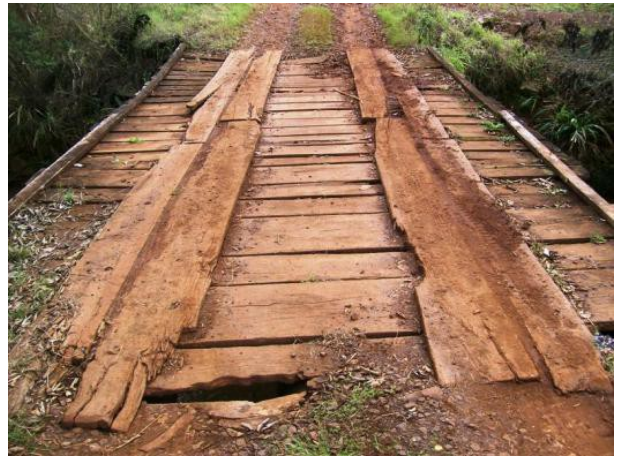
It can be seen on the bridge of Fig. 20 the defects caused by several factors, such as attack by fungi and insects; damages due to overloads, connection of the pieces, displacements, cracks, defects in the wood like cracks, knots, cup shakes, sweep, camber, warping, among others.

**Figure 20.** View of the board showing extensive damage

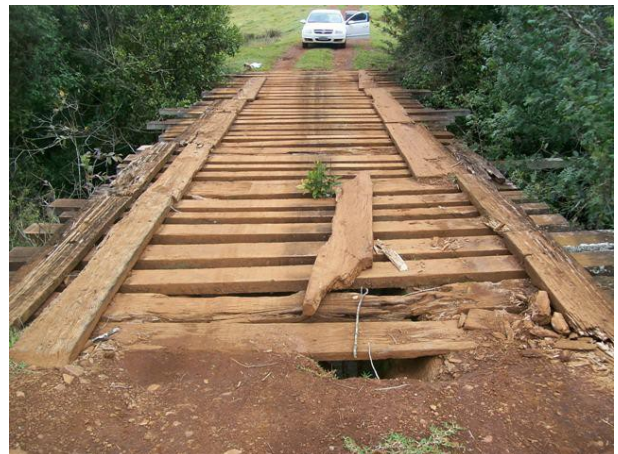
The bridge of Fig. 21 has its board endangered. All the wood presents widespread deterioration. Besides the board, this bridge

has the support structure with an apparent state of collapse of beams and reinforced concrete columns.

**Figure 21.** Overview of the board

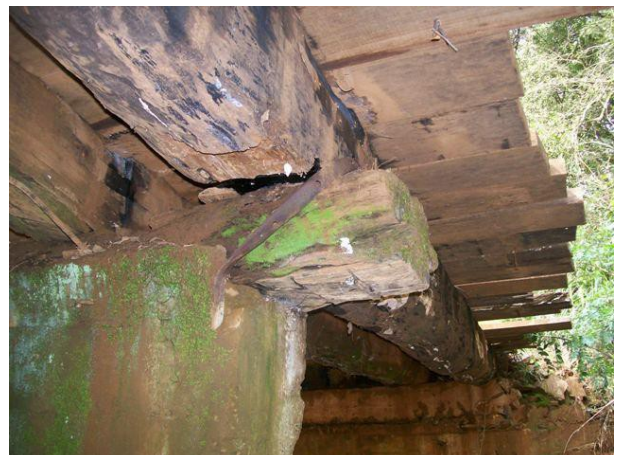
**Figure 22.** Cantilevered crossbeam to support beams

The bridge in Fig. 22 had its central pillar built with lean concrete and a large quantity of bush rocks without reinforcement. There is support for the stringers with a tree trunk in balance, without adequate fixation and without continuity of the crossbeam.

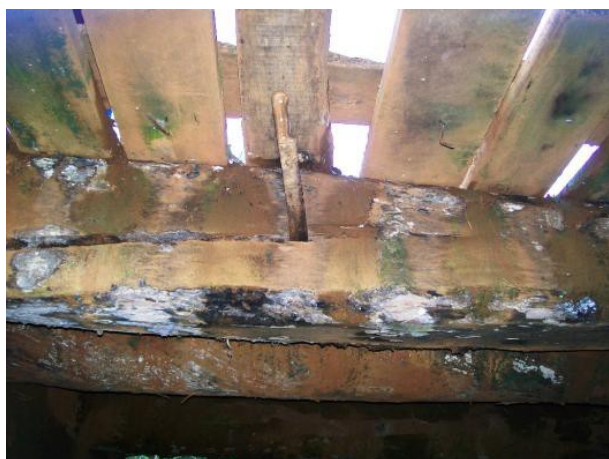
On the bridge of Fig. 23 we identified disruption of the wooden beam and damage in the board. It is observed fungal attack on all pieces of wood.

**Figure 23.** Disruption of the beam and fungi attack
