# DURABILITY INVESTIGATION OF CALVARIA BRIDGE AND ELECTROCHEMICAL REALKALINISATION AS A PREVENTIVE MEASURE

Meda NEDELICU<sup>1</sup>, Camelia NEGRUTIU<sup>2</sup>,

<sup>2</sup> Lecturer, Ph.D., Technical University of Cluj-Napoca, Faculty of Civil Engineering, Department of Structures, camelia.negrutiu@dst.utcluj.ro

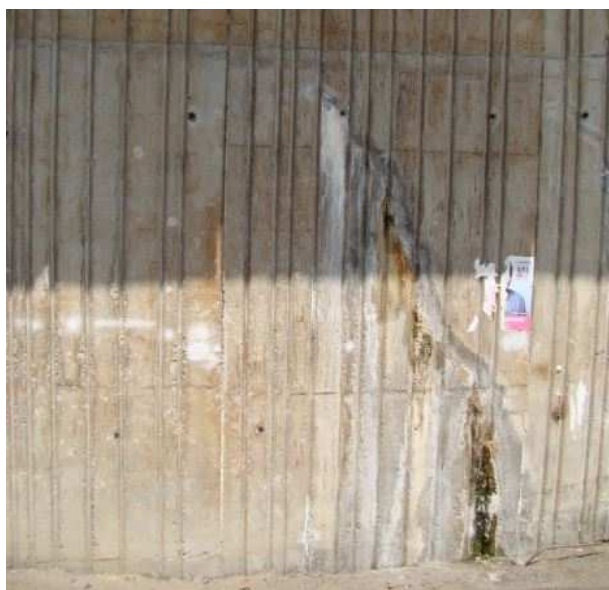
Large cracks can be observed in all structural elements. For example, shear force inclined, all-through cracks are present on the retaining walls (Fig. 3). These cracks have favored infiltration of surface waters, improperly evacuated from the traffic lanes upwards and also sprayed from downwards, which carried concentrated aggressive chemicals found in fuel leaks from heavy traffic and deicing salts from winter

maintenance. The red color abundant in the cracks is a sign of reinforcement corrosion products, as reached by the chemicals. The cracks also allowed  $\text{CO}_2$  to enter much easier, and so that the concrete layer was also carbonated.

**Fig. 3.** Crack in the retaining walls

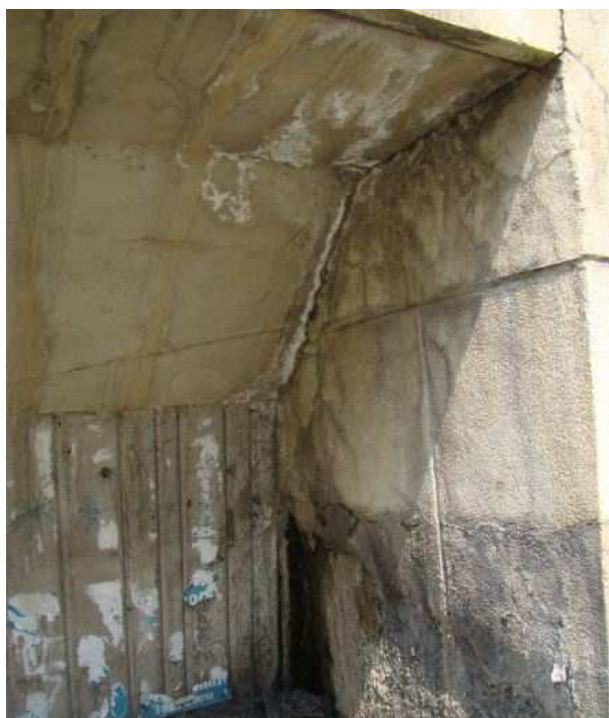
Other deteriorations are shown in Figure 4, at the joint between the retaining wall and the access path.

**Fig. 4.** Degradation of the retaining walls

The map-shaped cracking pattern may be caused by low temperatures in the winter, the so called phenomenon of d-cracking or from the alkali-aggregate reaction. The exposure of the aggregates due to freezing can be seen at the bottom of the retaining wall. All these defects intensify the aggressiveness of the upcoming attacks and reduce the overall capacity of the elements.

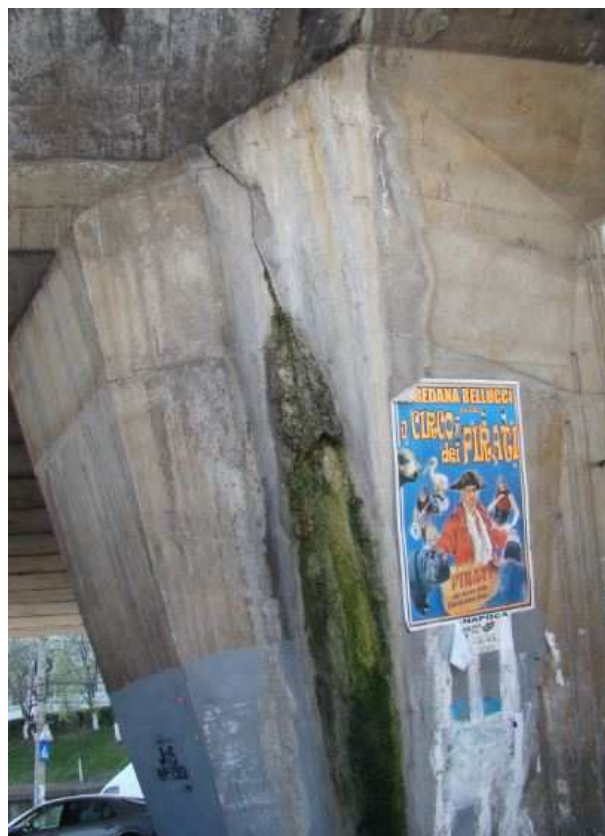
Over the abutments, Figure 5, a wide crack was observed, as a result of additional charges, thus stresses, due to the traffic increase over time. However, the crack is filled with moss and dark green and red products. Once again, the constant infiltration of waters will produce concrete disintegration, but this effect is not an immediate threat, due to the over sizing of the element.

**Fig. 5.** Crack in the abutments

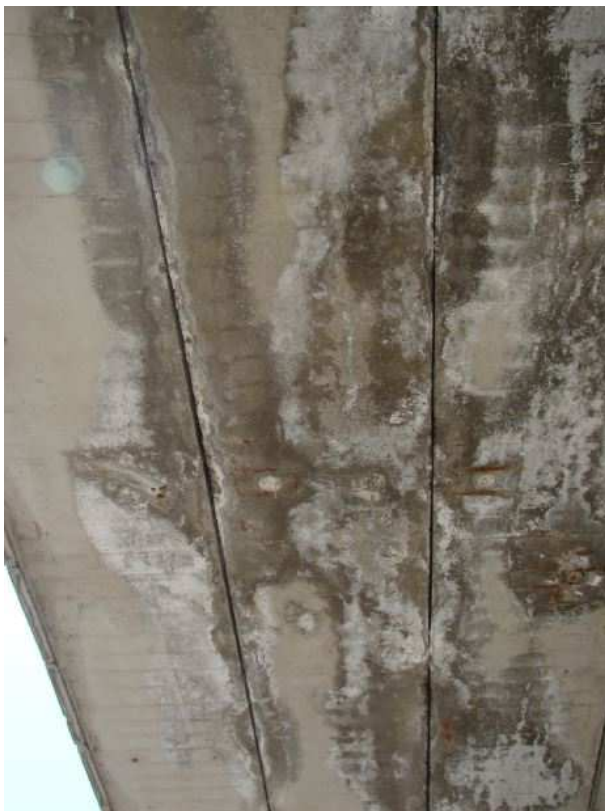
The main longitudinal elements are made of prestressed concrete and are presented in Figure 6. Although current design standards, such as SR EN 1992-1-1:2004, more specifically, the Eurocode 2, recommend a concrete cover as a function of the exposure

class, in 1987, the Romanian standards would only take into consideration how to ensure the bonding between the reinforcement and the concrete in evaluating the concrete cover. However, for prestressed concrete elements, the imposed cover is close to current exposure class-based calculations and therefore, this is not a sufficient reason for assuming deterioration. The quality of the concrete cover, the actual composition of the concrete, with low quantities of cement and quite high porosity is more likely to be the cause of deterioration. The corrosion in the stirrup, which can lead to a brittle shear failure, is so advanced that stirrup position is easily observed from the distance. Most water seepage is observed on external slabs and this is because the tilting of the roadway is from the shaft to the outside (sidewalk) and rainwater collection is poorly performed in this area.

**Fig. 6.** Marginal deteriorated beams

The white stains on the slab bottoms are actually deposits of salts formed due to the permanent water infiltrations.

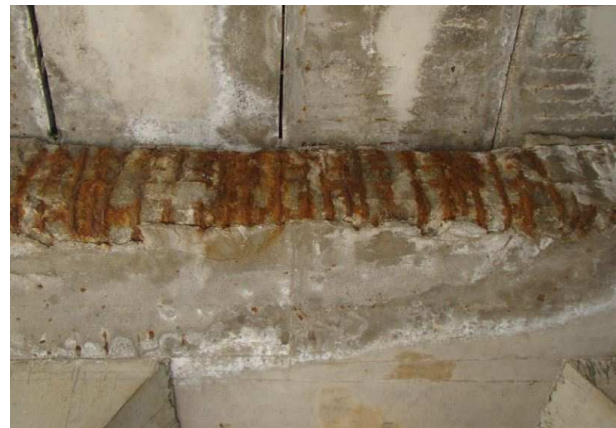
In Figure 7, a transversal simply supported beam in advanced state of corrosion is presented. Again, the shear capacity of the beam is at risk, with all the stirrups in corrosion, with reduced cross sections, especially where the shear-force is significant. At midspan, where bending stresses are important, the transverse reinforcement acts as a “sacrificial” element for the longitudinal reinforcement, allowing more time for the corrosion to reach the longitudinal bars.

**Fig. 7.** Corrosion of reinforcement

Due to carbonation and chloride attack, the expansive nature of the corrosion products, resulted in cover spalling when the tensile strength of concrete was exceeded. The presence of the sulfate attack is observed in these elements in Figure 8 by the appearance of white icicles.

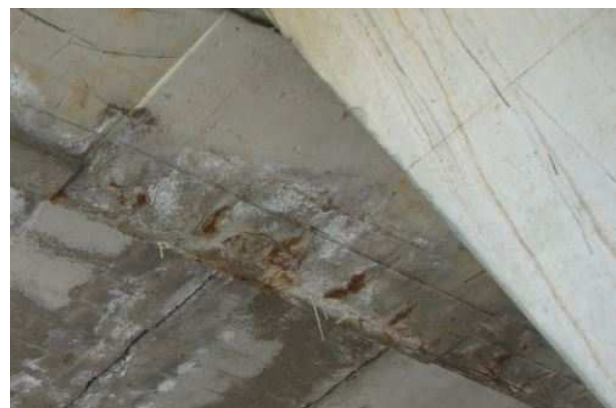
**Fig. 8.** White icicles.

These formations result from the washing by the infiltrating water of the calcium carbonate present in the concrete composition.

The most important problem that appears with the occurrence of these formations is that the concrete becomes more porous, and thus, more susceptible to  $\text{CO}_2$  attack, which induces the carbonation of concrete.

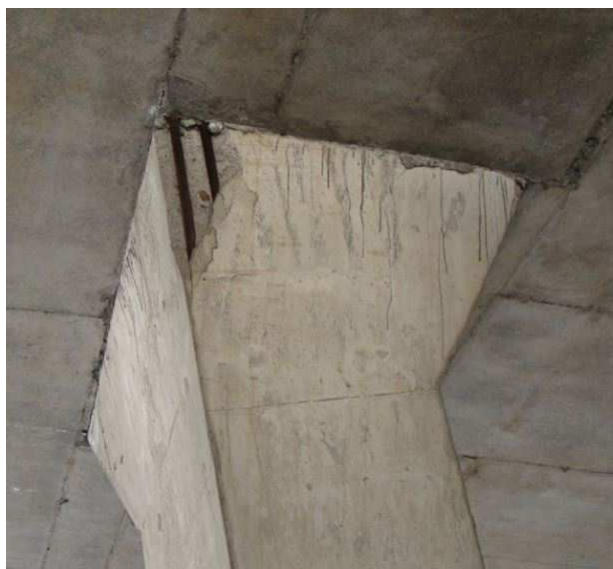
The columns have been recently consolidated. Therefore, visual defects, if existent, were hidden. However, a patch repair of a carbonated concrete, without the re-passivation of the embedded reinforcement is known only to worsen the rate of the corrosion and the exfoliation. Because the bridge pillars were subjected to the same aggressive environment which affected the rest of the structure, it is safe to assume that these elements were also damaged, consistent with Ball and Whitmore's halo effect theory [3]. The statement is confirmed by the exfoliation of the concrete cover in a consolidated pillar zone, as seen in Figure 9.

Fig. 9. Exfoliation of the new concrete layer

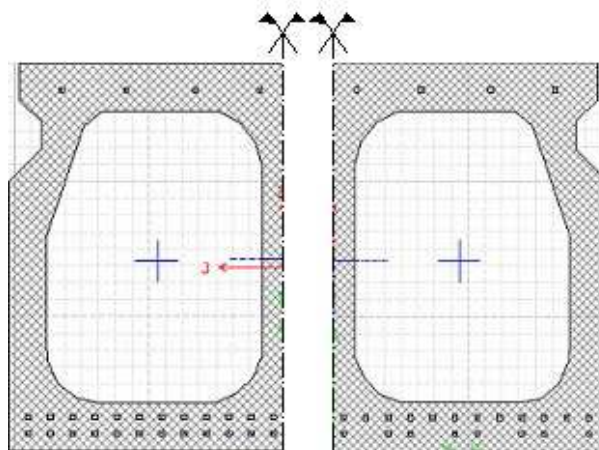
Fig. 10. Cross sections used in static analysis. Left section – scenario 1, right section – scenario 2

In the second scenario, the deteriorations were taken into account by removing the original number of strands in the assumption that they were reduced by corrosion and no longer carrying loads. The cross sections used in the analysis, for each of the two cases, are presented in Figure 10. The results show that a loss of 16.66% of the active reinforcement led to a vertical deformation at midspan increased by 1.30 mm in the second scenario, as compared to the first one, which means approximately 2.40%. The beam has sufficient rigidity due to the cross-sectional shape which brings a high inertial moment and which was not modified in either the scenarios, but could

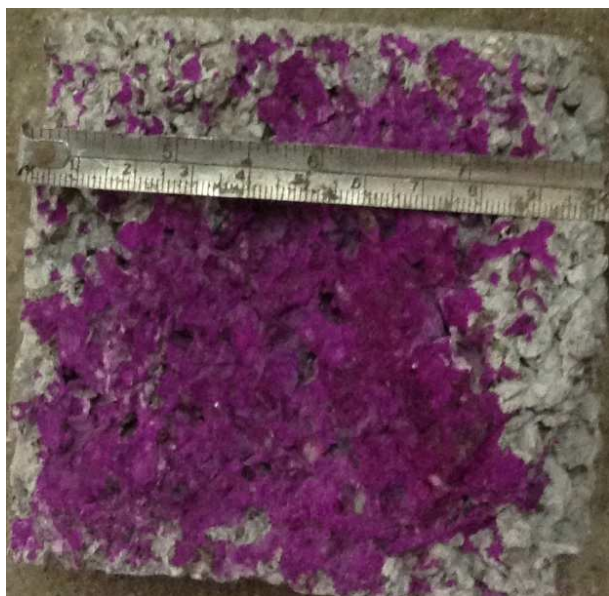
otherwise would not be prone for attack. For concrete samples with 0.40 w/c ratio, the carbonation depth was below 2 mm, whereas for the 0.60 w/c ratio, the average depth measured on the side where the realkalinisation was later applied was 10 mm, as shown in Figure 13.

Fig. 13. Measuring the depth of carbonation

The carbonation depth was lower for samples with  $w/c = 0.40$ , as the resulting structure was denser compared to that of the samples with higher  $w/c$  ratio. Therefore, it is obvious that a low  $w/c$  ratio has a significant influence in the development of compressive strength, the increased density of the concrete matrix and thus the decrease in carbonation depth. This observation is also confirmed by Aguirre and Mejía [1] and by Al-Khaiat et al. [2].

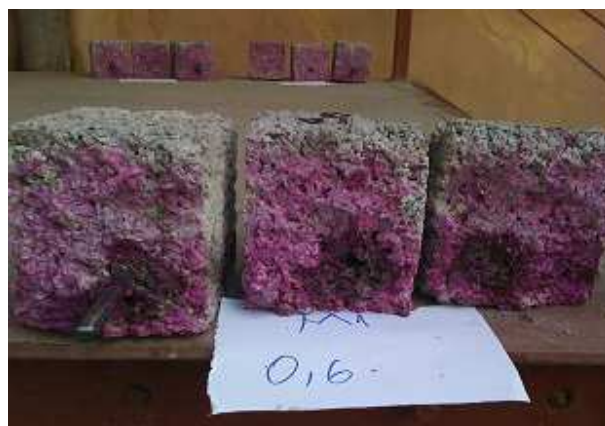
Fig. 15. Prisms after ER treatment

By comparing a fresh split section before the ER treatment (Figure 13) with one after 9 days of treatment (Figure 15), one can see the presence of the pink color at the bottom of the prisms, where the ER was concentrated. Furthermore, after treatment completion, deposits of salt crystals on the reinforcement

It can therefore be observed that, with the acid-base indicator Phenolphthalein, the samples were re-basified and the pH increased up to 10 from a value less than 8, according to previous research. The high porosity of the samples with 0.60 w/c ratio, which was disadvantageous for the ingress of the carbon dioxide, as compared to the 0.40 w/c ratio, also helped accumulate alkaline solution in the ER and controlled a faster repair. Moreover, in the ER the most important effect occurred in the cathode zone, where a flow of OH<sup>-</sup> ions resulting from the semi-reaction of the water reduction is generated, resulting a higher local increase of the pH level, as compared to zones situated further apart.

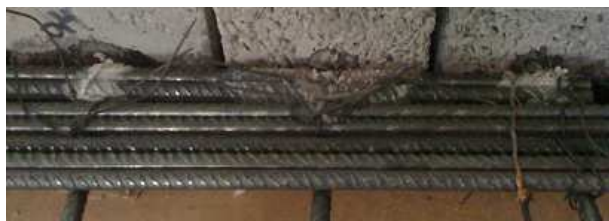
were also observed, confirming the occurrence of electrochemical reactions, as shown in Figure 16.

**Fig. 16.** Deposits of salt crystals
