# DYNAMIC PROPERTIES IDENTIFICATION FOR A TIMBER FRAMED MASONRY HOUSE

Alexandru ALDEA<sup>1</sup>, Andreea DUTU\*<sup>2</sup>, Sorin DEMETRIU<sup>3</sup>, Daniel I. DIMA<sup>4</sup>

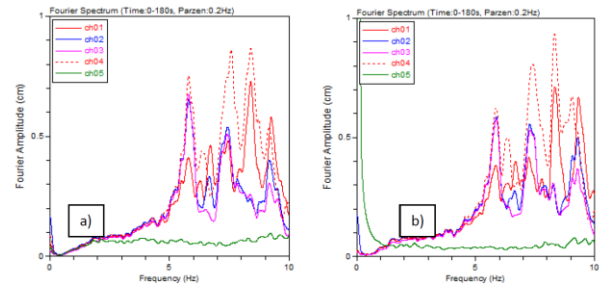
**Fig. 22.** Fourier amplitude spectra of velocity records for Scheme 1, transverse direction, Measurement 1 (a) and Measurement 2 (b)

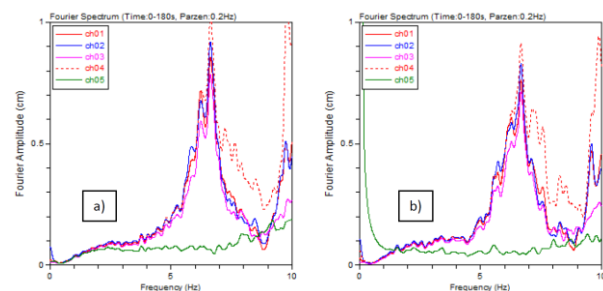
**Fig. 24.** Fourier amplitude spectra of velocity records for Scheme 2, longitudinal direction, Measurement 1 (a) and Measurement 2 (b)

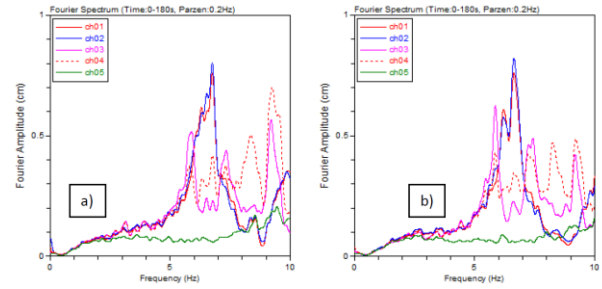
Fig. 28. Fourier amplitude spectra of velocity records for Scheme 3, longitudinal and transverse direction, Measurement 1 (a) and Measurement 2 (b)

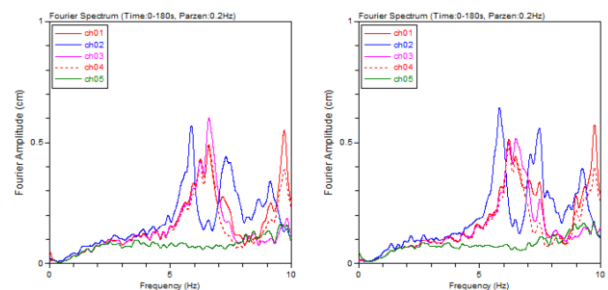
Fig. 30. Fourier amplitude spectra of velocity records for Scheme 4, Longitudinal Direction, Measurement 1 (a) and Measurement 2 (b)

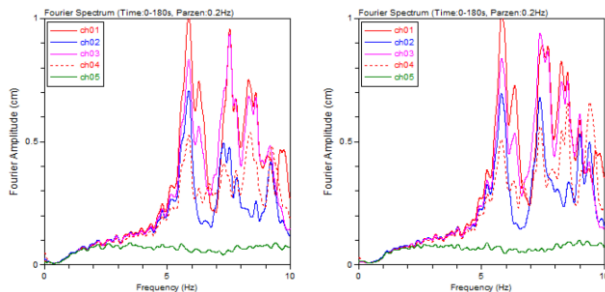
**Fig. 32.** Fourier amplitude spectra of velocity records for Scheme 5, Transverse Direction, Measurement 1 (a) and Measurement 2 (b)

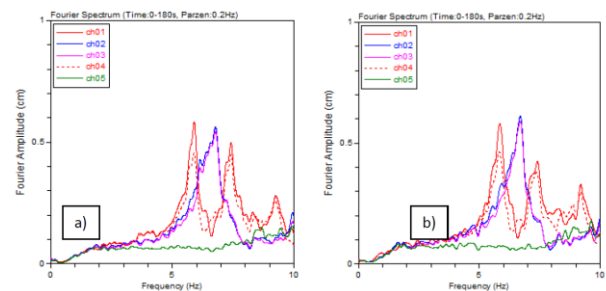
**Fig. 33.** Fourier amplitude spectra of velocity records for Scheme 6, Longitudinal and Transverse Directions, Measurement 1 (a) and Measurement 2 (b)

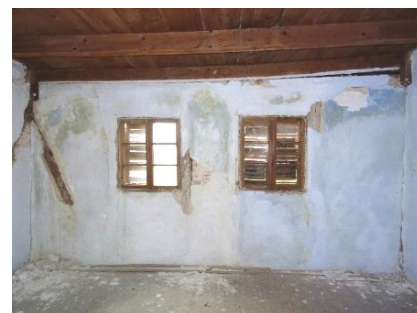
It should be noted that the actual state of the house is poor, with partial detachment of the infills from the timber (the building will be part of a museum repairing program).

**Fig. 36.** Masonry infill separation cracks visible inside the house

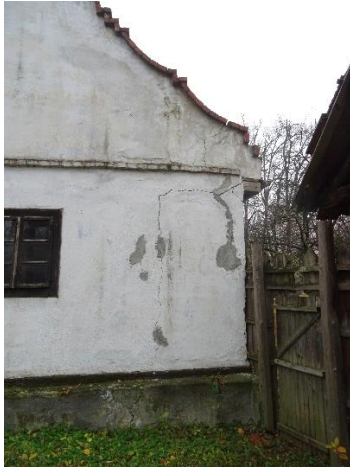
Lushan earthquake [3] and they agree for house type C, in China, for which the structural system is similar to the Romanian one (Figure 35). Details of the houses differ in terms of connections and shape of the infill, but the overall structure with the simple principles of timber framed masonry such as flexibility of timber frame stiffened by the masonry infill panels is similar. Typologies can be compared, as they both represent timber framed masonry houses. The state of the house C when the measurements were done was that it has sustained minor to moderate damage in the infills during the Lushan earthquake. This is comparable with the state of the house studied in this paper, which presented many cracks at the interface between the infills and the timber frame (Figure 36). These cracks appear to be cause only from the foundation settlement of the house (Figure 37). The timber frame did not show damage, though.

**Fig. 37.** Cracks on the exterior of the house
