# CASE STUDIES OF PROTECTION MEASURES AT ROMANESQUE CHURCHES IN CLUJ COUNTY, ROMANIA

## **2. INTERVENTIONS ON THE ROMANESQUE STRUCTURES IN CLUJ COUNTY**

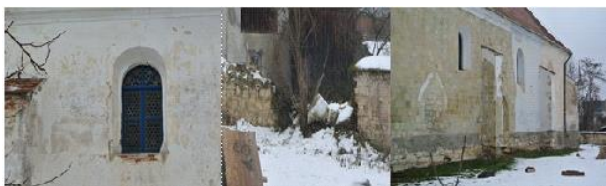
Fig.5. Exterior degradations

Today the stone foundations, which are preserved since the 13<sup>th</sup> century, are in a rather bad condition and some parts are missing. Exterior plasters are severely damaged. The walls of the nave have cracks on the exterior at the top, most likely due to ground settlement. The opening of larger windows, which are replacing the small and narrow Romanesque ones, led to the appearance of cracks. The fence wall shows cracks in certain points and one area collapsed.

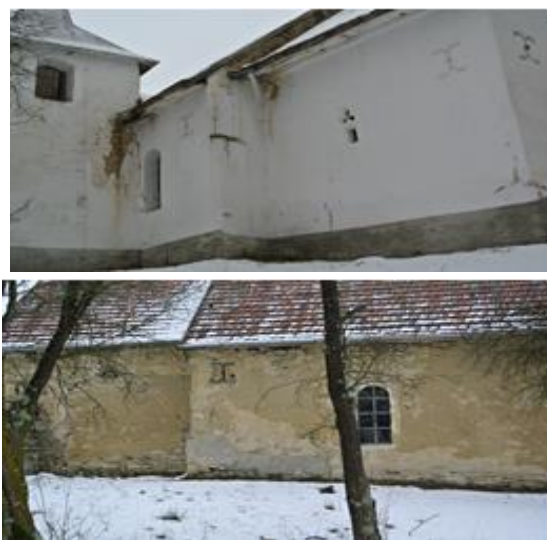
Fig.6. Degradation of northern and southern facade

Fig. 7. North facade and south facade

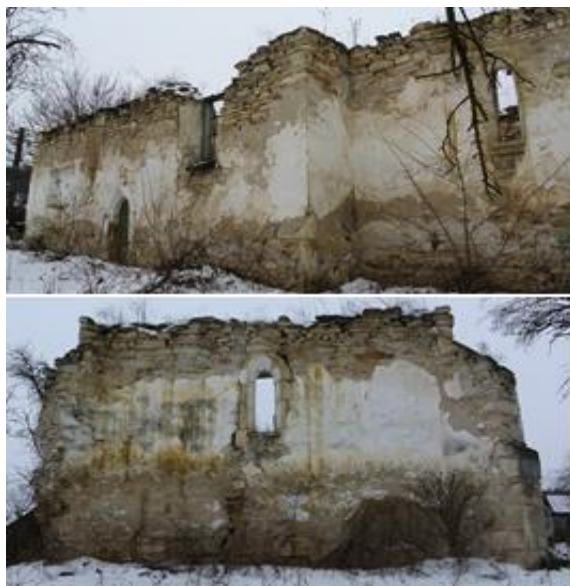
**Fig. 8.** Ruins of the Church
