# ASSESSMENT OF THE MATERIAL PROPERTIES OF A FIRE DAMAGED BUILDING

In this study, the material properties of a fire damaged single storey building located at No. 2 Gbogi Street, Akure, Ondo State are assessed through physical, mechanical and chemical analysis of both concrete and steel samples collected from the remains. A sizeable proportion of the building collapsed during the fire incidence. The building had been in existence for six years up till the time of the fire which lasted for over three hours (based on information gathered from surrounding residents).

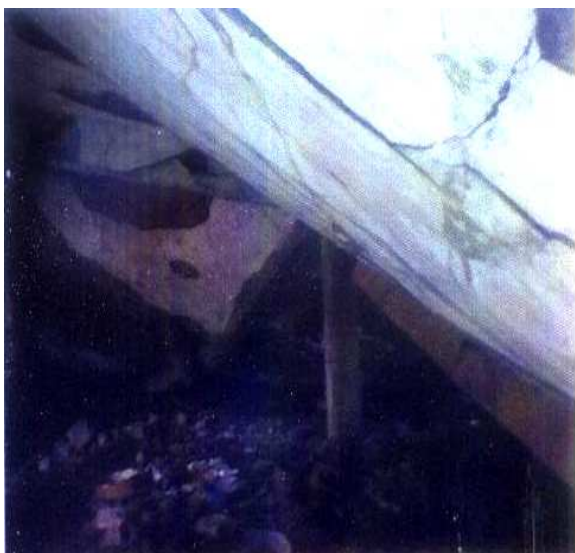
**Fig. 1.** Building section showing collapsed column, slab and beam

Based on subjective assessment of the building and what can be inferred from figures 1, 2 and 3, the building has undergone severe damage indicated by the collapse of columns, beams and slabs which has resulted in failure of the internal concrete fabric and the reinforcements.

Based on the results of all the analysis carried out in this study, it is recommended that the building should be totally demolished. The building is beyond repairs because all the properties fall below standard requirements.

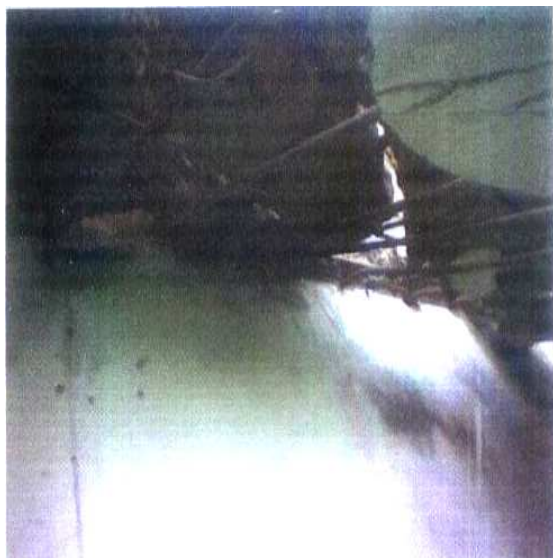
**Fig. 2.** Damaged floor slab with exposed reinforcement

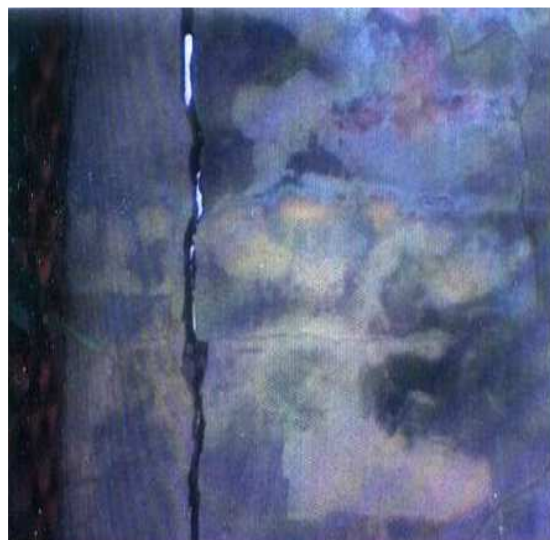
**Fig. 3.** Crack in the wall close to a column
