# SHEAR AND FLEXURAL BENDING STRENGTH OF MASONRY WALL RETROFITTED USING PP-BAND MESH

## ABSTRACT

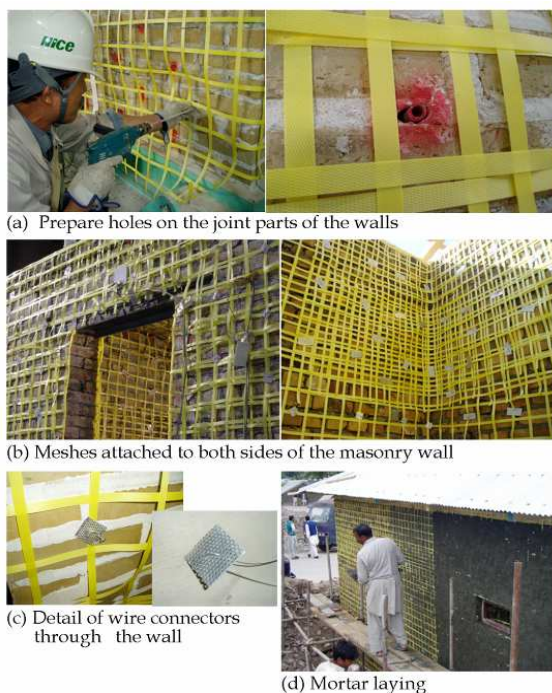
**Fig. 1.** PP-band retrofitting method

Fig. 1 shows the retrofitting procedure during the retrofitting of the full-scale house model. The advantages of the PP-band mesh retrofitting method compared to the other earthquake strengthening technology are as follows:

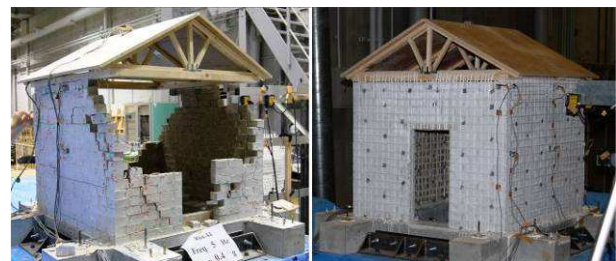
In order to verify the effects of PP-band mesh retrofit method, a number of experimental and numerical studies have been done on 3-dimensional miniature and real scaled structures with static and dynamic loading conditions (Fig. 2) (7)-(9).

**Fig. 2.** Shaking table testing on non-retrofitted and retrofitted scale house model.

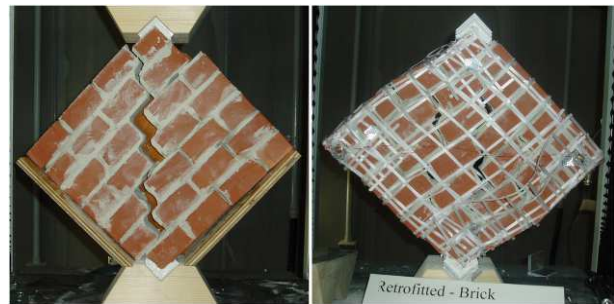
Fig. 5 shows the non-retrofitted and retrofitted specimens at the end of the test, which corresponded to vertical deformations equal to 0.71mm and 50mm, respectively. In

the non-retrofitted case, the specimens split in two pieces after the first diagonal crack occurred and no residual strength was left. In the retrofitted case, on the other hand, diagonal cracks appear progressively, each new crack followed by a strength drop. Although the PP-band mesh influence was not observed before the first cracking, after it, each strength drop was quickly regained due to the PP-band mesh effect. Although at the end of the test almost all the mortar joints were cracked, the retrofitted wallettes did not lose stability.

**Fig. 5. Failure patterns of burned brick masonry wallettes (left) without retrofitting (right) with retrofitting (10)**

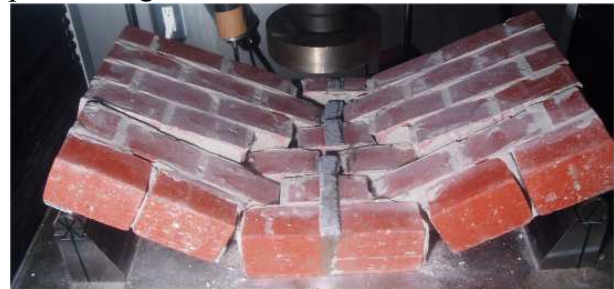
Fig. 16 shows the non-retrofitted and retrofitted masonry wallettes at the end of the test, which corresponded to a mid-span net deformation equal to 2.8mm and 60.0mm, respectively. In the non-retrofitted case, the specimens split in two pieces just after the first crack occurred at mid-span, and no residual strength was left. In the retrofitted case, on the other hand, although PP-band mesh influence was not observed before the first cracking, after it, strength was regained progressively due to the PP-band mesh effect.

Fig. 16. Failure patterns of brick masonry wallettes with and without retrofitting by PP-band mesh.
