# REHABILITATION AND MODERNIZATION OF BUILDINGS - CASE STUDY

The aim of this paper is to present the rehabilitation process of a building and the analysis of the best options chosen for the modernization process.

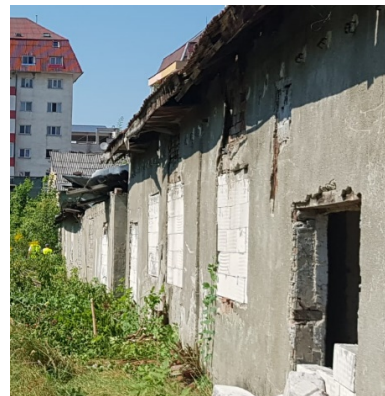
Fig. 1. Existing situation of the building

The building is a linear single-story structure, with a ceramic tile rooftop.

The perimeter walls and transversal walls were made of brick masonry filled with lime sand mortar, on simple concrete foundations prepared with unsorted aggregates. The foundation base depth was given by the geotechnical study. The perimeter walls were wooden frames. Each frame had three openings, two marginal and one, lower, central. Frame posts were made out of steel pipe. The floor above the ground floor consisted of wooden beams, arranged at spaces of 80...90 cm, in the middle.

The connection between the building parts was created through a connecting structure. Architecturally, these form a single building, consisting of a series of rooms and a longitudinal corridor. The supporting walls were made of brick masonry with a thickness of 49 centimeters. They were supported on plain concrete foundations with a width of 50 cm and a depth of 90 cm. The floor was made out of reinforced concrete over the longitudinal and transverse walls and is composed of transverse main beams (arranged transversely across the walls) and three longitudinal beams. These divided the openings of the main beams into four equal parts.

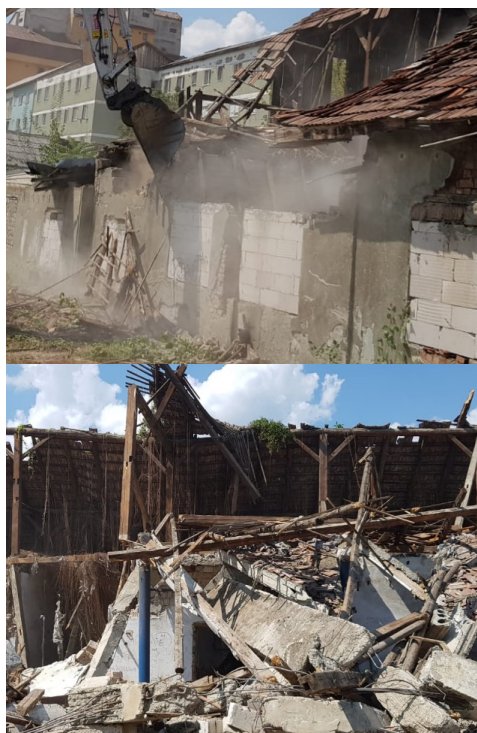
**Fig. 2.** Aspects from the demolition process

The parts of the building that presented an advanced stage of degradation were demolished (Fig. 2).

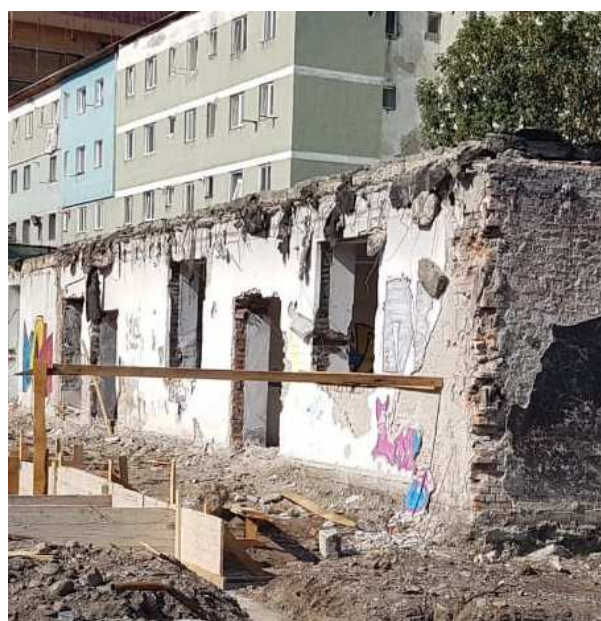
**Fig 3.** Part of the building without the old roof

The new building will have two new spaces. For the future vertically-extended construction, a reinforced concrete frame structure will be adopted. The columns will be positioned according to the details of the technical plans elaborated in the rehabilitation project. They will be provided with custom foundations, designed and dimensioned according to the strength and stiffness requirements of the current design regulations. In order to add a level to one of the buildings, the old roof and wood frames will be demolished (Fig. 3) and new reinforced concrete beams will replace them.

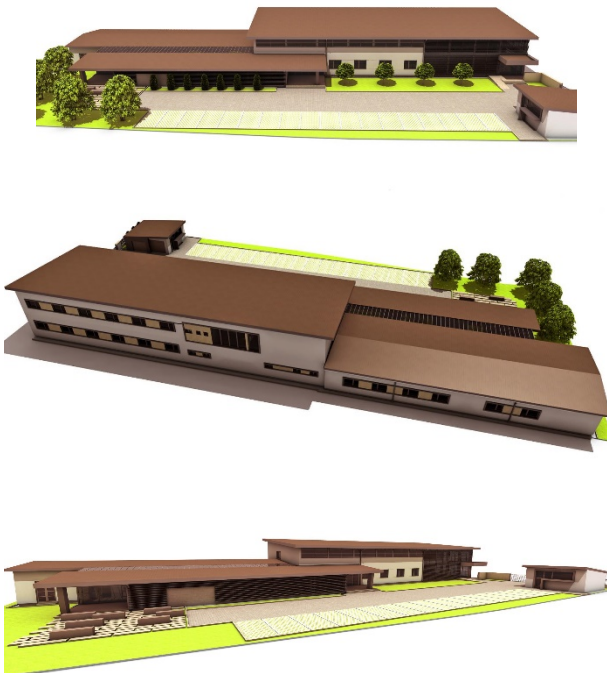
**Fig. 4.** Proposed new building

The building will be thermally insulated with expanded polystyrene of 15 cm thickness. Pluvial waters will be captured in the gutters and will be led to the external sewerage system connected to the pipes. The wood material that will be put into different parts of the new buildings in order to protect the elements was fireproofed and treated with fungicidal and antiseptic substances (Figs. 4 and 5).

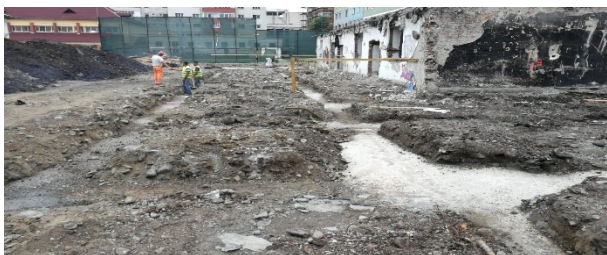
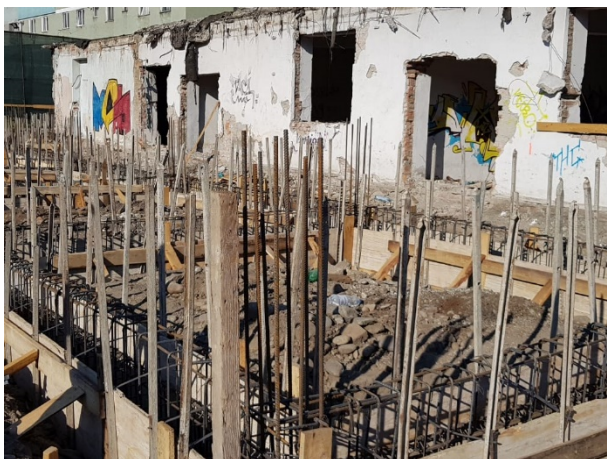
**Fig. 5.** Current stage of the rebuilding phase
