# DURABILITY INVESTIGATION OF CALVARIA BRIDGE AND ELECTROCHEMICAL REALKALINISATION AS A PREVENTIVE MEASURE

Meda NEDELICU<sup>1</sup>, Camelia NEGRUTIU<sup>2</sup>,

<sup>2</sup> Lecturer, Ph.D., Technical University of Cluj-Napoca, Faculty of Civil Engineering, Department of Structures, camelia.negrutiu@dst.utcluj.ro

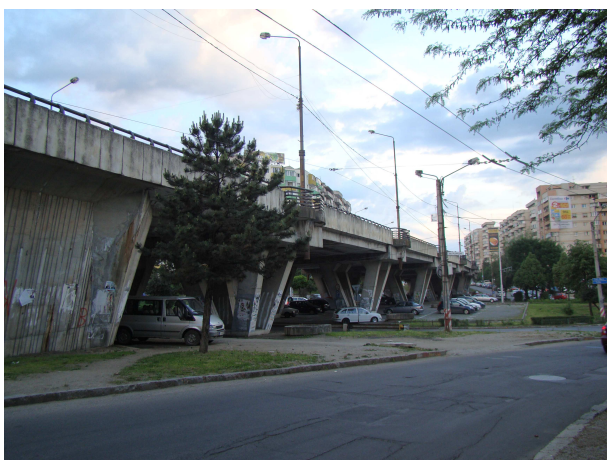
Fig. 1. Calvaria Bridge

The Calvaria Bridge is located on the artery entry in Cluj-Napoca from Oradea. The bridge is part of a road junction that provides the main traffic flow direction Oradea - Cluj-Napoca center and crosses an intersection in the central area (Fig. 1).

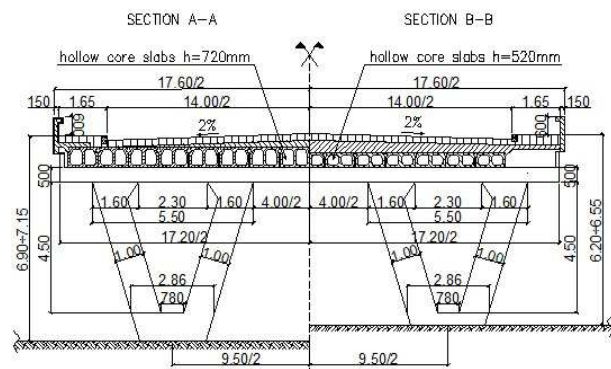
Fig. 2. Cross sections of the bridge [6]

Furthermore, each clear span of 12 m is supported by 13 hollow-core, one way slabs, 520 mm-high, while each clear span of 23 m is supported by 16 hollow-core, one way slabs, 720 mm-high (Fig. 2). The reinforced concrete piles are spaced at 9.5 m and are composed of four different columns with a cross-section of  $700 \times 1000\text{ mm}$ , raked up at top with a wide reinforced concrete beam. All elements of the infrastructure have direct foundations.

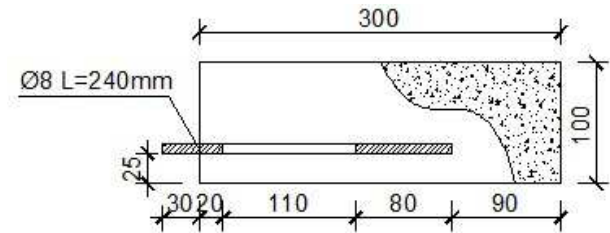
**Fig. 11.** Prism sketch (all dimensions are in mm)

Two concrete compositions were tested: M1 with water/cement (w/c) ratio of 0.60 and M2 with water/cement (w/c) ratio of 0.40. The details of the compositions are presented in Table 1 and Table 2. For each composition a series of 100x100x300 mm prisms were cast, each with an embedded reinforcement, 8 mm-diameter BSt500S, as shown in Figure 11. The reinforcement was partially covered with silicone coating, as expressed by the shaded area.

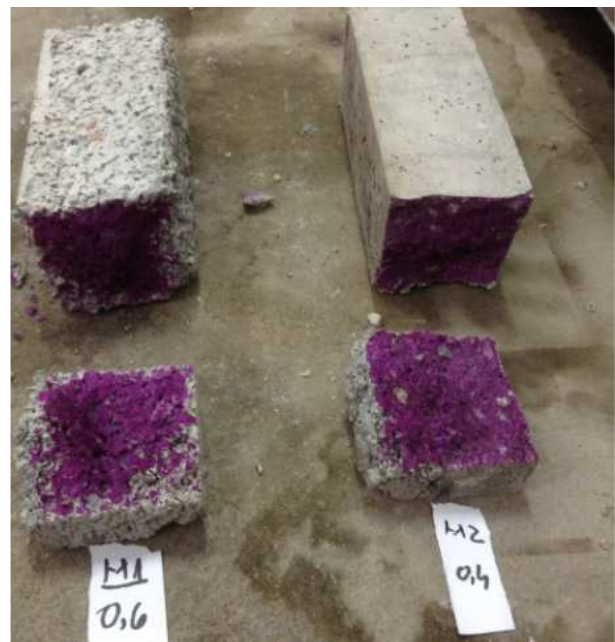
**Fig. 12.** Split samples

After casting, the concrete prisms were demoulded after 24 h, cured for 4 days in water and then placed in the natural environment for 63 days in order to obtain a carbonated layer less than 25 mm-thick, which is the size of the concrete cover. The specimens were then split and the carbonated depth was evaluated by spraying the concrete surface with a 1% Phenolphthalein solution, as shown in Figure 12.

Although granite aggregates are usually important for concrete strength development, especially for high strength concrete, in this case, the resulting concrete samples were visibly porous as the aggregates lacked a high percentage of fine particles. Thus, deleterious gases, such as carbon dioxide are able to easily penetrate a weak, porous structure, which

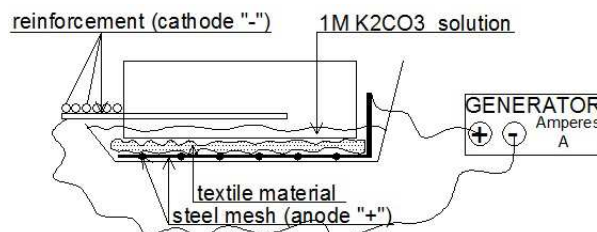
Fig. 14. System design

The set up test for RE is presented in Figure 14. An 8 mm-diameter mesh of ribbed steel, type Bst500S, acted as anode, while the embedded reinforcement acted as cathode. A textile material was laid on top of the steel mesh in order to maintain high and uniform moisture at the base of the samples. The anolyte solution was 1M of  $K_2CO_3$ . Several reasons brought about the use of  $K_2CO_3$ : the use of granit stones as aggregates, which might

lead to alkali-aggregate reactions and the minimization of the potential efflorescences. Electrolytes are substances that facilitate the transfer of electric charge and lead to the production of  $OH^-$  ions around the steel bar, causing a restoration of the initial level of alkalinity of the concrete. The electric generator induced an electric current; the intensity of the current was set to a constant  $8.54 A/m^2$ , for a 9 day treatment period.
