# CASE STUDIES OF PROTECTION MEASURES AT ROMANESQUE CHURCHES IN CLUJ COUNTY, ROMANIA

## **2. INTERVENTIONS ON THE ROMANESQUE STRUCTURES IN CLUJ COUNTY**

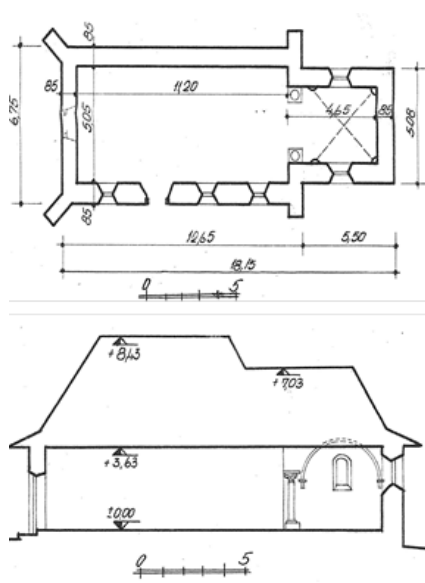
**Fig.2.** Plan and longitudinal section

In 1959, a general restoration project was carried out, after observing the need of an elevation to the altar subsequent to the dislocation of the south-east corner due to soil overhaul. Since 1955, actions as consolidation and renovation works have been conducted for the restoration of the dislodged masonry, repairs to walls, plaster repairs, new coatings and spoilage.

The major part of the church walls was in good stand, only the south-east wall was dislodged and the connection with the other wall was broken, probably because of the inadequate soil, which broke and the water seeped into it. Before starting the interventions on the masonry in the specific points for the reconstruction of the wall, it was necessary to dig some deep pits near those specific points, in order to be able to determine the depth of the foundation or whether the ground under the foundation was massively weakened or not. At the indicated places, the masonry was removed to the appropriate depth in order to determine the rate of displacement of the blocks, if necessary until reaching the foundation. The dismantled parts of the foundation were redone with cement mortar. Parts of the roof were in

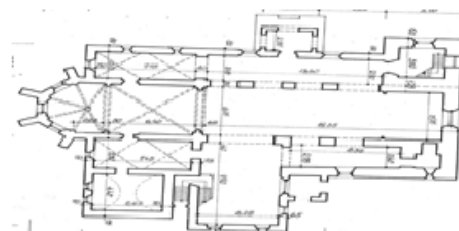
**Fig.3.** Ground plan

Following the project report and the brochure signed by Entz Geza and Sebestyen Iosif, it turns out that in 1964 the church went through important transformations, which negatively influenced its stability. The demolition of the old tower walls, located on the longitudinal axis of the building and the execution of a new tower in lateral position, towards the south, were part of the mentioned interventions.

One of the shortcomings was that the longitudinal walls from the middle were stuck to the rigid connection formed by the inner wall of the old tower and there have been ground settlements that have affected the old walls. The vertical deviation of the longitudinal walls occurred mainly due to some initial construction defects. It could not be admitted that these distortions occurred over time, due to the magnitude of the observed ones. Over the time, the initial defects were accentuated and dangerous cracks appeared, therefore the stability conditions changed, imposing the need of consolidation works.

In 1958, the supporting walls of the northern exterior wall have been executed without prior approval in the space between the main façade and the first corner, which contributed to the accentuation of existing cracks.

longitudinal walls separately without considering their binding. Thus, it was proposed the study of a sufficiently rigid transverse reinforcement system, to reduce the free length of high deformed walls. At the same time, the longitudinal reinforcement of these walls and the injection of all cracks with slurry cement have been proposed to restore the necessary continuity. The transversal consolidation system was planned to be unitary, both for the central part and for the outer walls of the collateral galleries. It was decided that the substructures were not necessary, although in the project it was shown that the existing foundations were deepened up to a maximum of one meter.

At the altar it was considered necessary to provide a reinforced concrete belt at the top of the outer walls where the overlaying layer of the vaults was connected. It was necessary to remove the cement plaster from the base and to solve the irregularity of the roof on the northern side, which led to the deposit of a large amount of snow difficult to clean. The proposed works were indicated to be done by avoiding the destruction of paintings that could have been found or of older inscriptions (NIH, 1961-1963).
